**CITY OF LOS ANGELES
DEPARTMENT OF PUBLIC WORKS
LA SANITATION AND ENVIRONMENT**

**30-DAY REPORT
ON
UNPLANNED DISCHARGE TO 1-MILE OUTFALL OF
UNTREATED WASTEWATER ON JULY 11 AND 12, 2021**

**HYPERION TREATMENT PLANT
12000 VISTA DEL MAR, PLAYA DEL REY, CALIFORNIA
(NPDES PERMIT NO. CA0109991, ORDER NO. R4-2017-0045)**

AUGUST 13, 2021

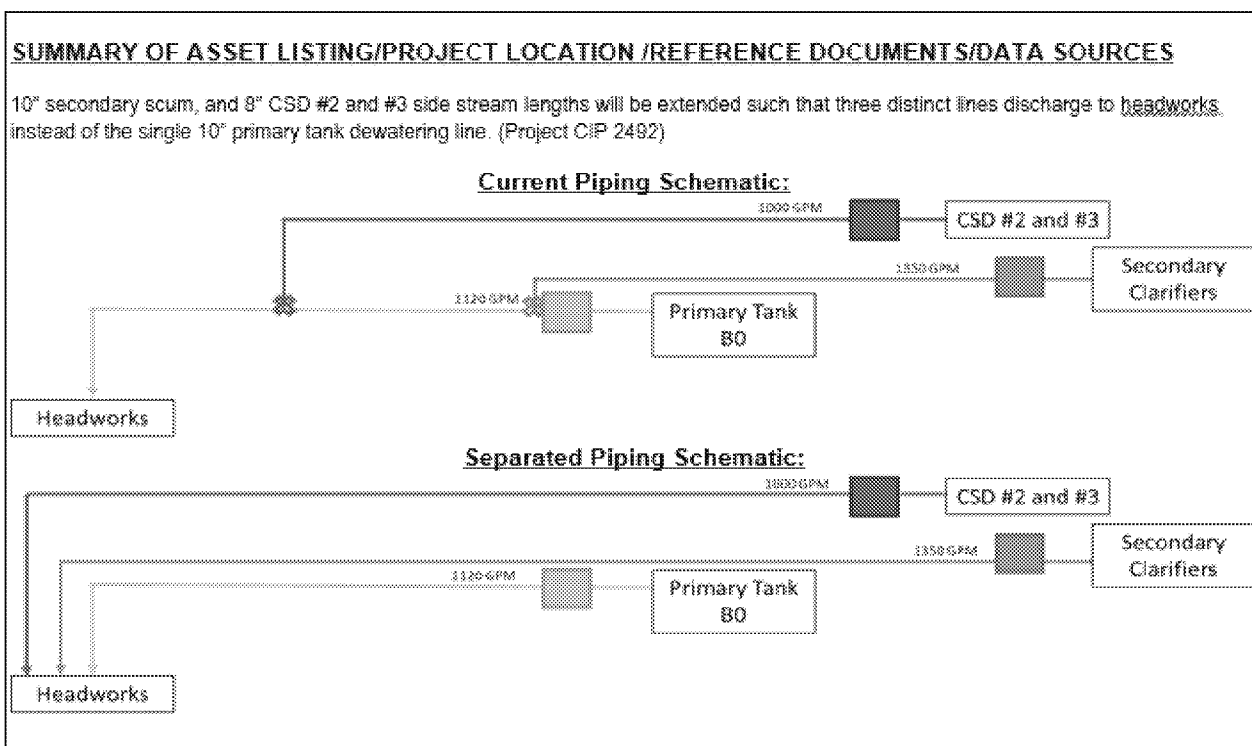
Figure 36 – Stormwater Discharge Piping Separation

1. Storm Discharge Piping Separation Project (CIP 2492). This project improves system performance and eliminates the possibility that materials of sewage origin (MOSO) from Secondary Clarifiers and Primary Tank Dewatering will be discharged into the 1-Mile Outfall Project completion is expected by December 2022. (Refer Figure 36)

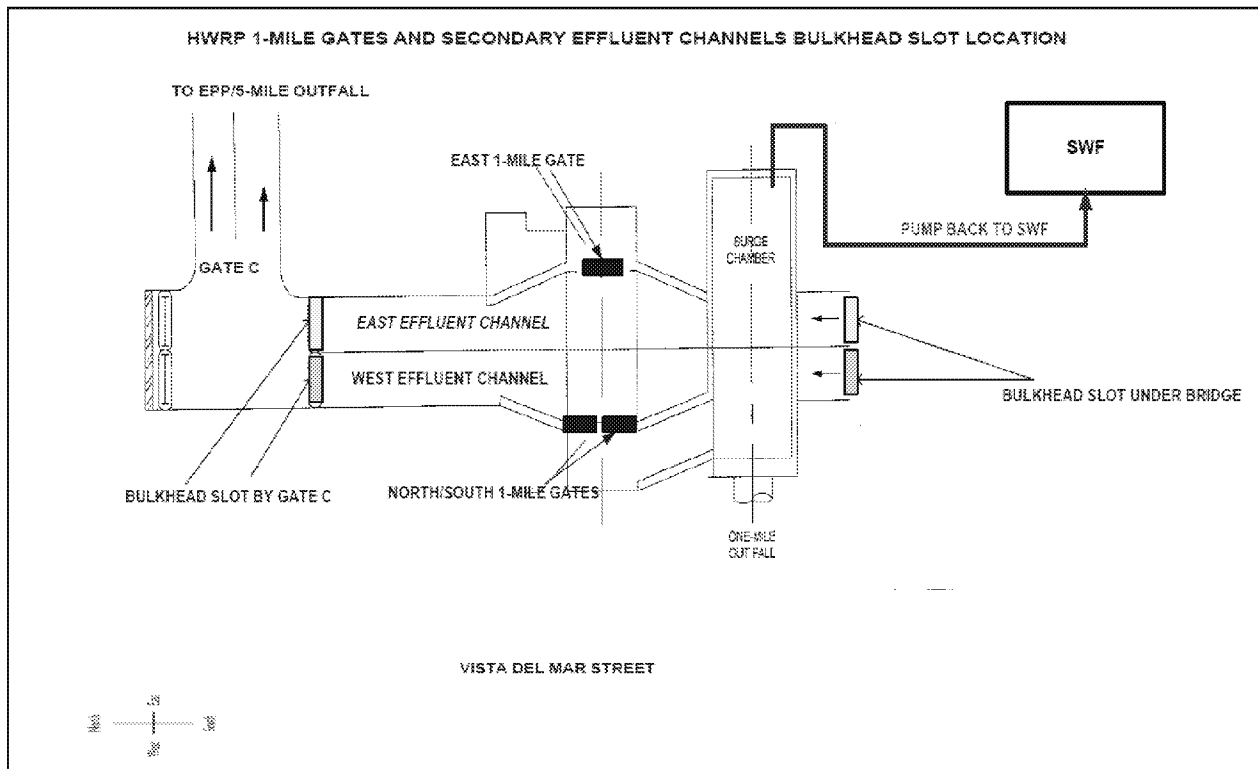
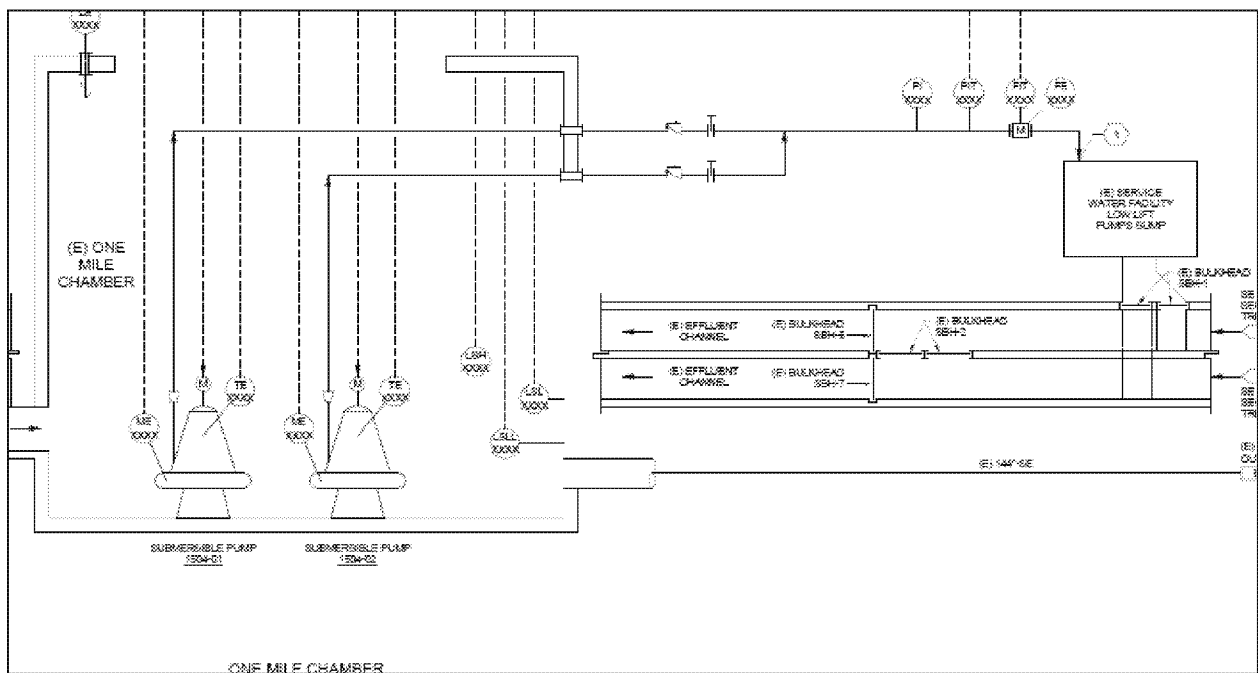
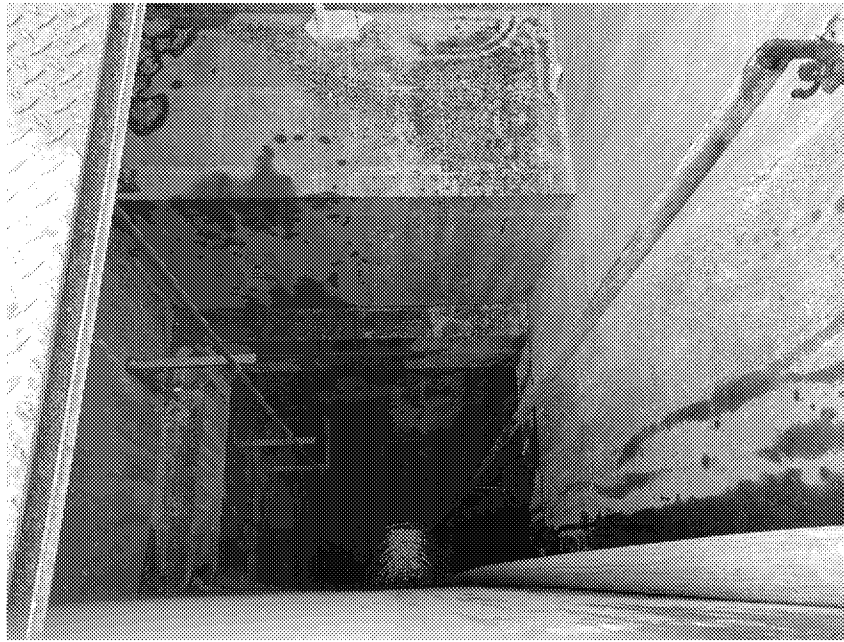
2. 1-Mile Chamber Pump Station (CIP 2487). This project will install an automated pumping system to pump water out of the 1-Mile Surge Chamber back to SWF. Project completion is expected by November 2022. (Refer Figures 37, 38, and 39)

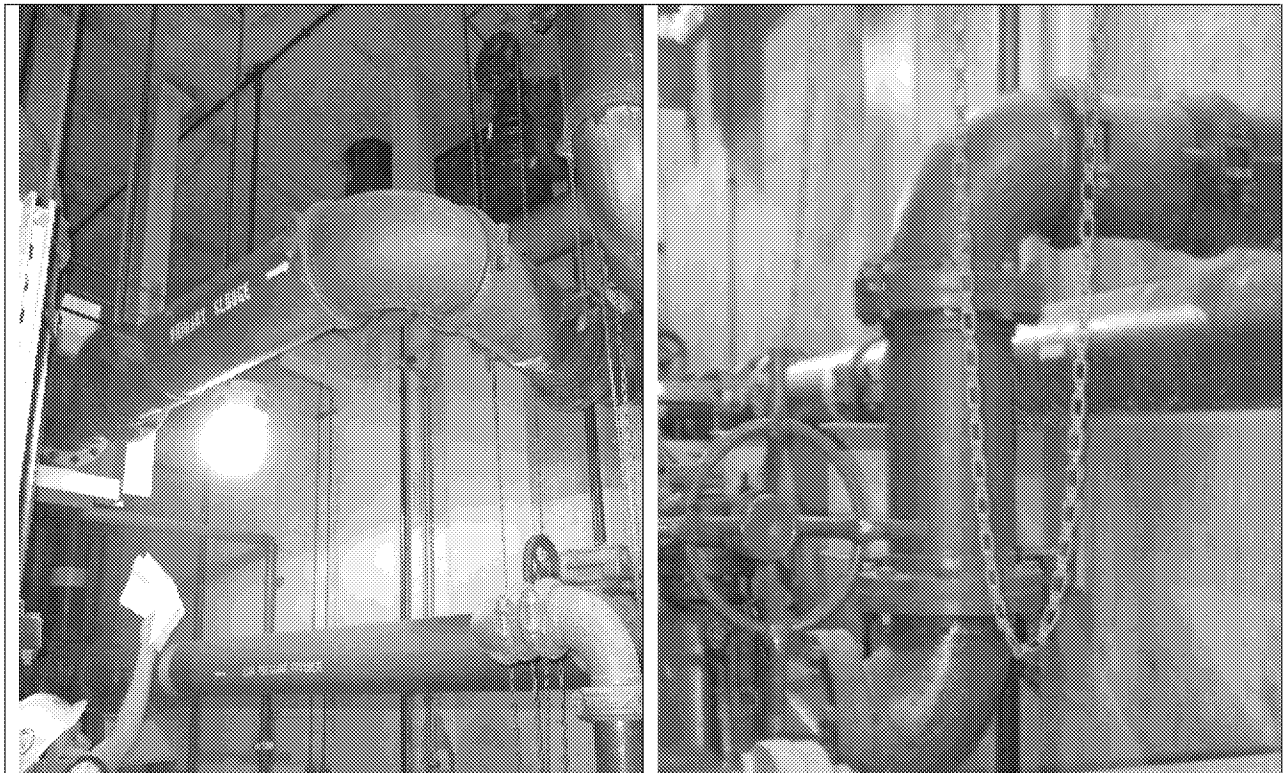
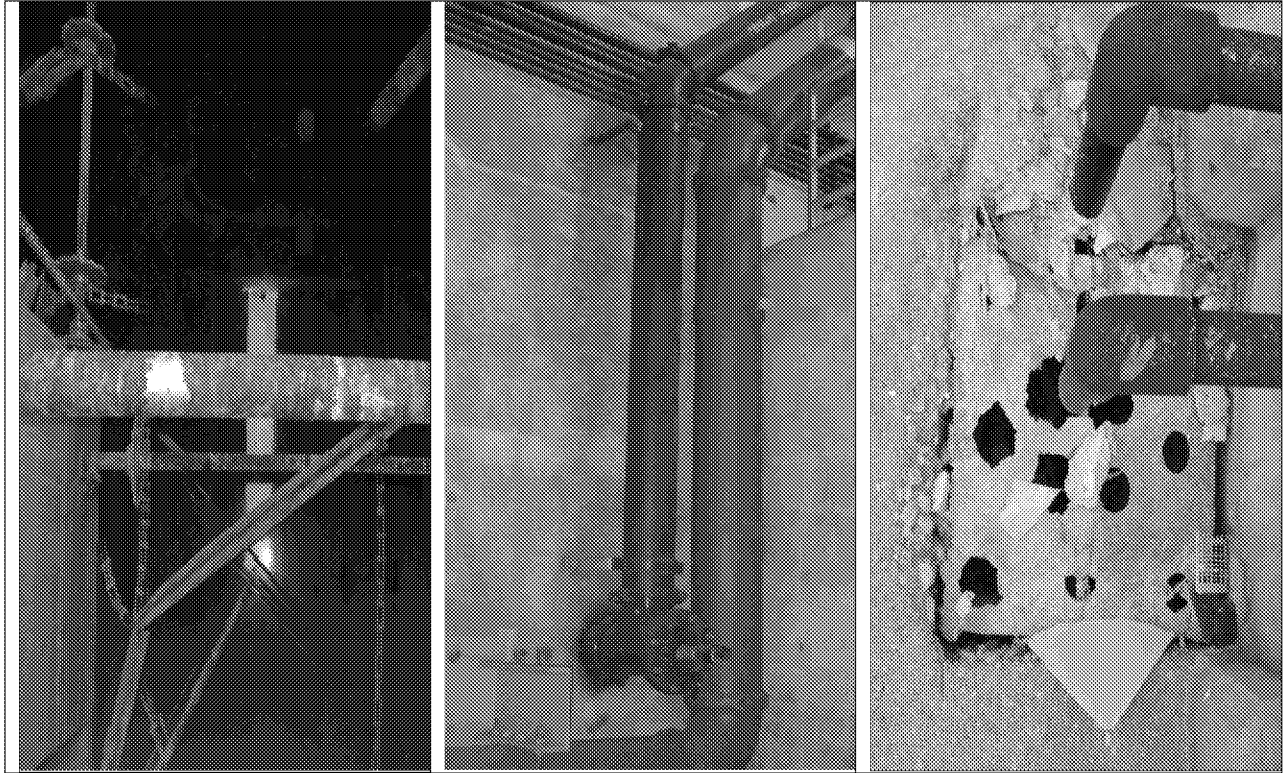
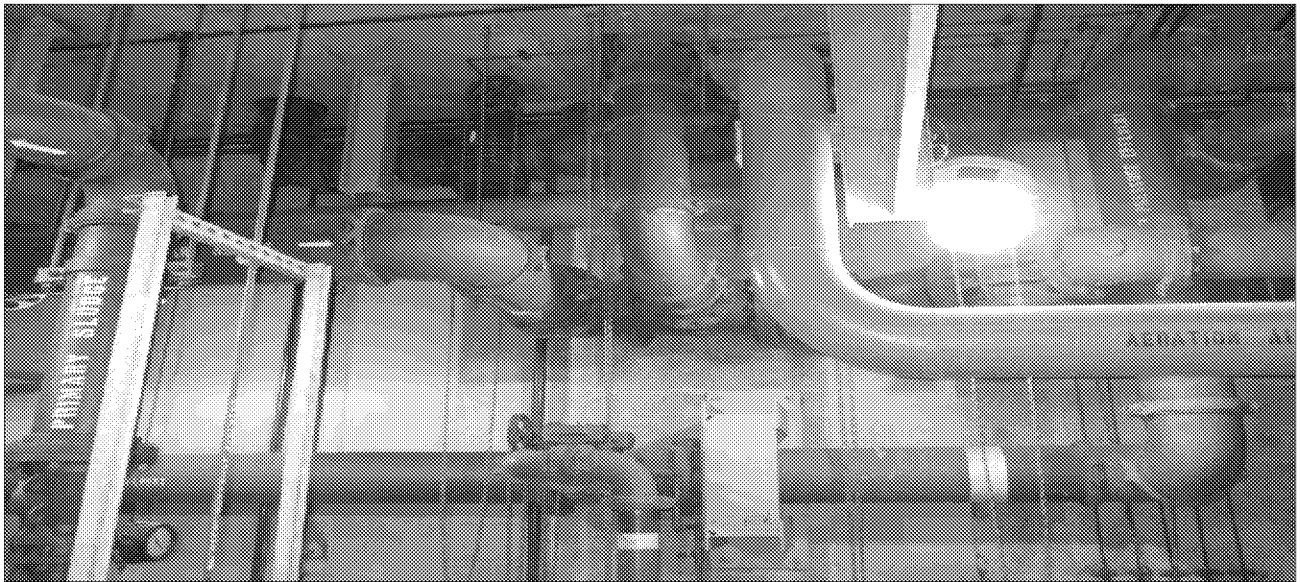
3. Primary Tanks B0, B5 and C0 Upgrades (CIP 2445). This project will modify primary tanks eliminate plugging in the suction piping of Tanks B0, B5, and C0. Project completion is expected by May 2022. (Refer Figures 40, 41, and 42)

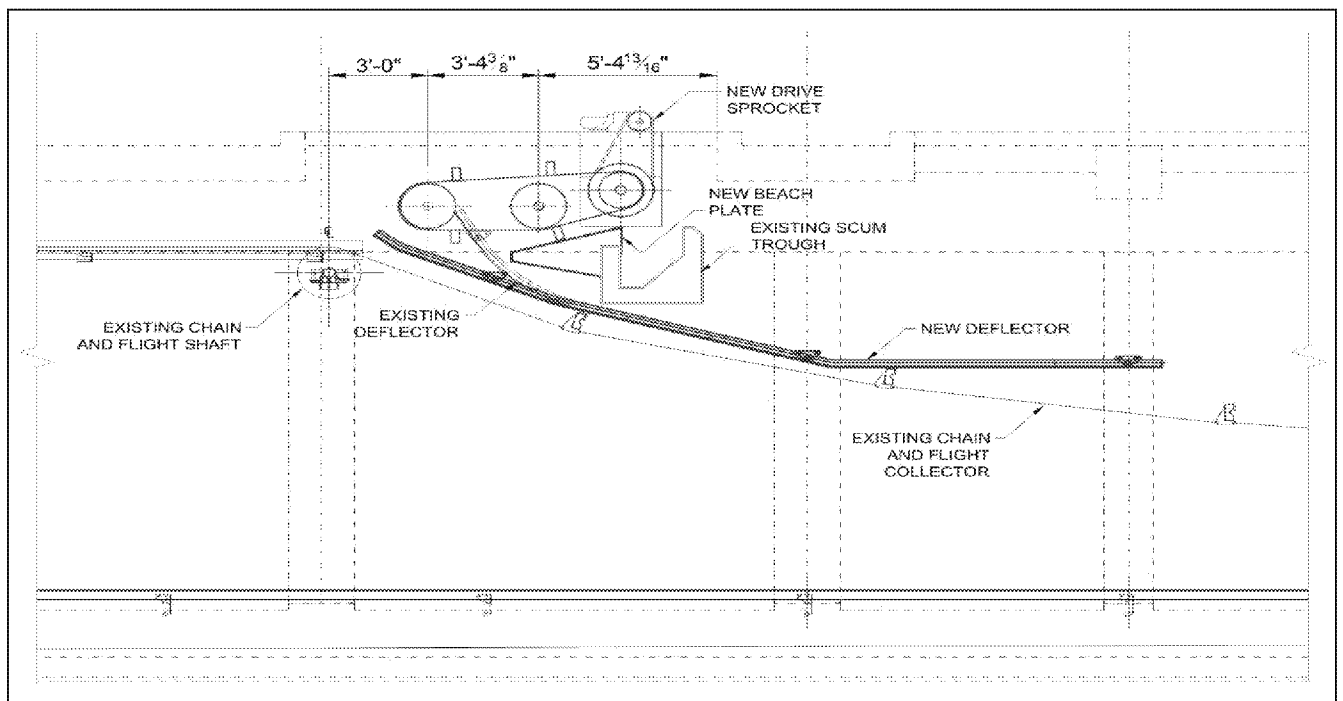
Figure 43 – Primary Tanks Skimmer Improvement

4. Primary Tanks Skimmer Improvements (CIP 2446). This project is to replace the helical skimmers with power skimmers in Batteries A, B, and C to improve solids capture. Project completion is expected by May 2022. (Refer Figure 43)

4. Primary Tanks Skimmer Improvements (CIP 2446). This project is to replace the helical skimmers with power skimmers in Batteries A, B, and C to improve solids capture. Project completion is expected by May 2022.

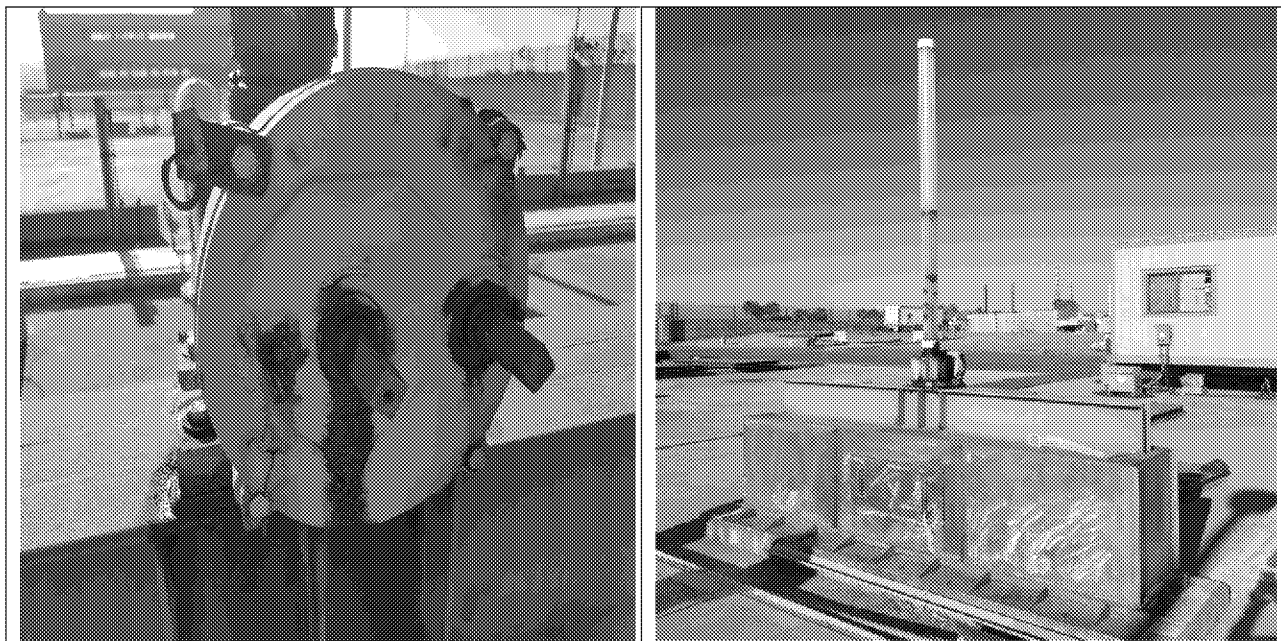
Figure 44 – Primary Influent Sluice Gates

5. Primary Tank "A" Influent Sluice Gates Modifications to Bulkheads (CIP 2477). This project will remove and replace all four primary influent sluice gates and replace two bulkheads in the influent channel and three bulkheads in Primary Battery A influent channel. Project completion is expected by May 2022. (Refer Figure 44)

5. Primary Tank "A" Influent Sluice Gates Modifications to Bulkheads (CIP 2477). This project will remove and replace all four primary influent sluice gates and replace two bulkheads in the influent channel and three bulkheads in Primary Battery A influent channel. Project completion is expected by May 2022.
